SUMMARY

1234 Main Street Charlotte NC 28278

10/02/2024 9:00AM

Hazel Middleton
Certified Master Inspector
Tier 1 Home Inspections
7042002334

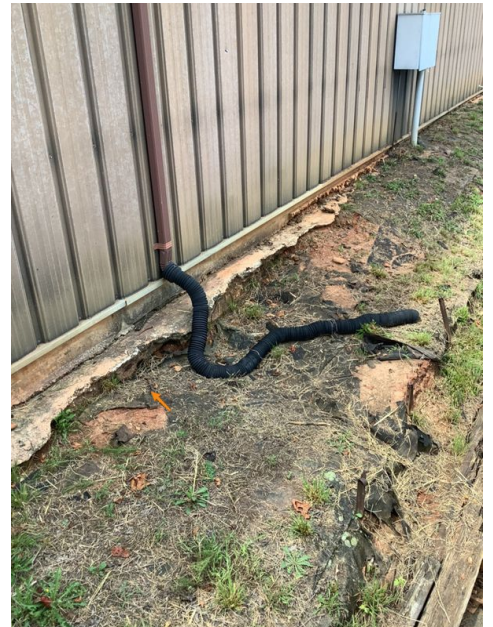
3.3.1 Grading/Lot Drainage

AREA(S) PRESENT IN NEED OF ATTENTION

There were areas of grading present that will not allow rainwater to adequately run away from the structure. Repairs to any grading as needed for proper rainwater runoff is recommended to be performed by a grading or landscaping contractor.

Contact a qualified grading contractor.

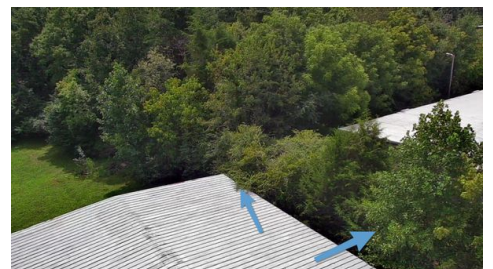
3.4.1 Vegetation Observations

TREE(S) - LIMBS WITHIN 10 FEET OF ROOF

Tree limbs were present that were covering portions of the roof surface or within 10 feet of the roof. Tree limbs within 10 feet of the roof should be trimmed away to provide air and sunlight to the roof, allowing the roof surface to adequately dry after rainfall events. Leaves from trees can also clog downspouts and gutters allowing them to overflow. Trimming or removal of the offending branches as needed is recommended to be conducted by a tree trimming company.

Contact a qualified tree service company.

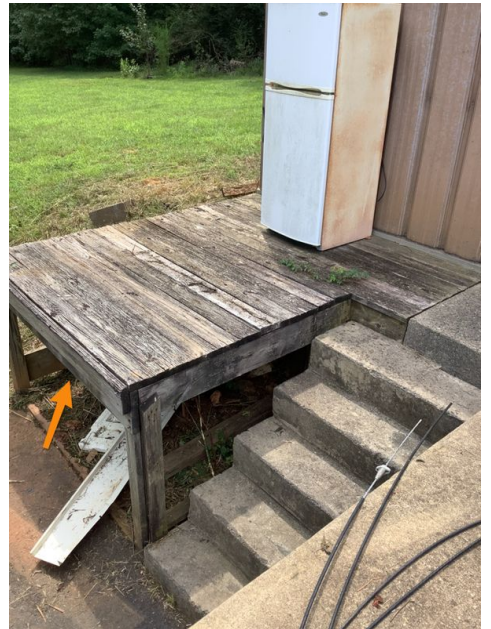
3.5.1 Decks

DECK(S) - HEAVILY WEATHERED

Wooden components of the deck and/or stairs were heavily weathered in areas. Decks require periodic maintenance including pressure washing and staining, and neglecting this maintenance can lead to water damage and compromise the integrity of the deck. An evaluation of this deck and repairs or replacement of any damaged wood, including framing members is recommended to be performed by a deck contractor.

Contact a qualified deck contractor.

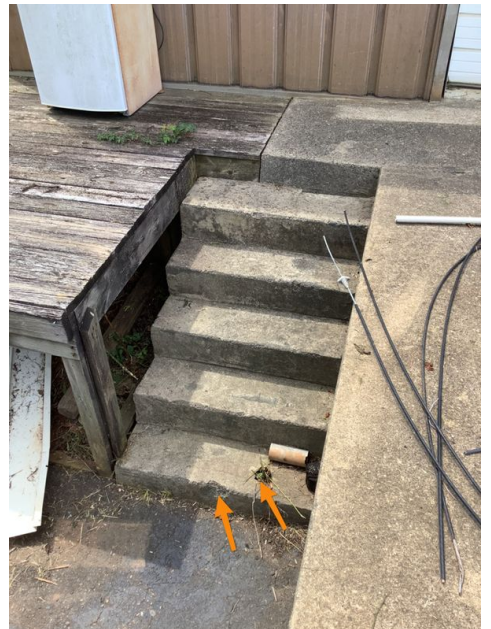
3.7.1 Stairs & Steps

MASONRY STAIRS - DEFICIENCIES

The masonry stairs had areas of missing mortar, cracking in the brick, and loose brick(s) present. Repairs to the masonry is recommended to be performed as needed by a masonry contractor.

Contact a qualified masonry professional.

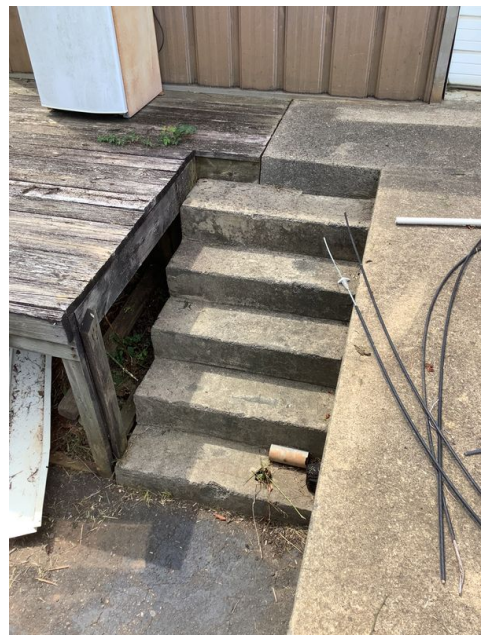
3.8.1 Guardrails, Stair Rails, & Handrails

GUARDRAIL - MISSING

SFTY - The referenced area was 30" above finished grade, within a 36" area of the deck or porch, and a proper guardrail was not present. The installation of a proper guardrail is recommended to be installed here for safety by a qualified person.

Contact a qualified deck contractor.

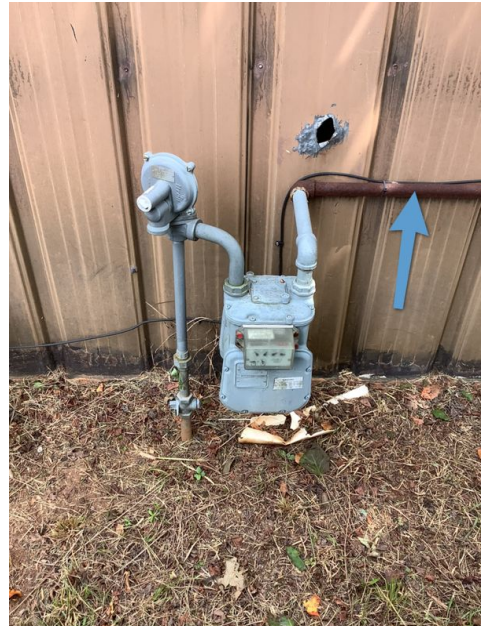
3.15.1 Gas Meter/LP Tank Information

GAS PIPES - SURFACE RUST

Some degree of surface rust was present on the gas piping in the area of the gas meter. Sanding and painting the pipes with rust-inhibiting paint is recommended to extend the life of the pipes.

Contact a qualified professional.

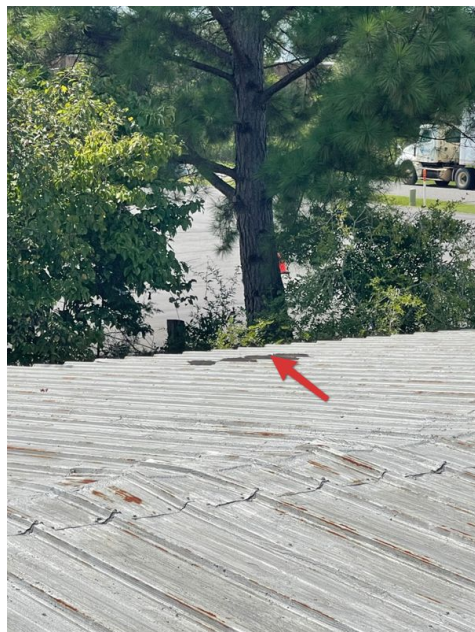
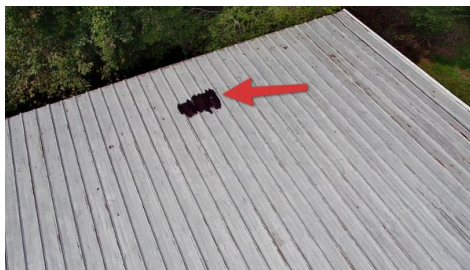
ROOF SURFACE - HEAVY USE OF MASTIC

Mastic was used on the roof surface at the referenced area(s). A properly performing roof covering should be able to resist leaks without the use of mastic (roofing tar). An evaluation of the roof is recommended to be conducted by a qualified roofing contractor with repairs or replacement of the covering performed as needed.

Contact a qualified professional.

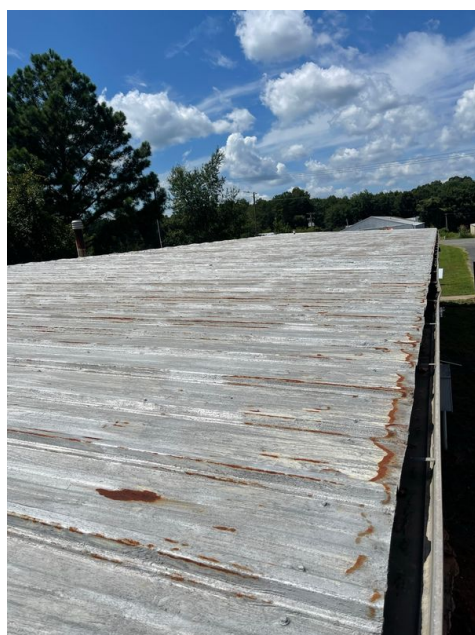
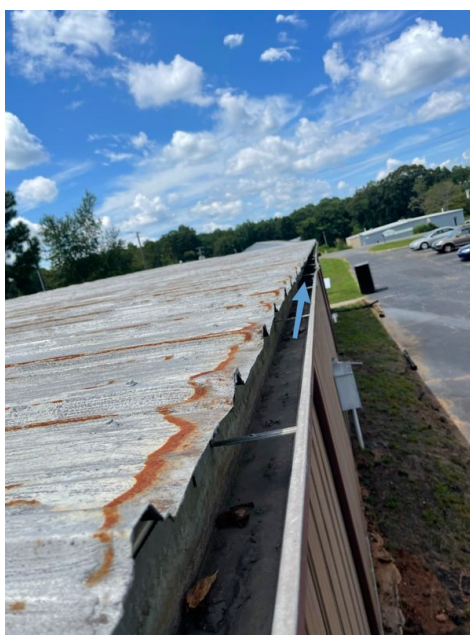
4.6.1 Gutters/Downspouts

GUTTER(S) - LEAVES/DEBRIS

Leaves and/or organic debris was present in the gutters. This can create blockages in the downspouts, allowing water to overflow the gutters. Repairs to remove all organic debris from the gutters and downspouts is recommended to be performed by a qualified person.

Contact a qualified professional.

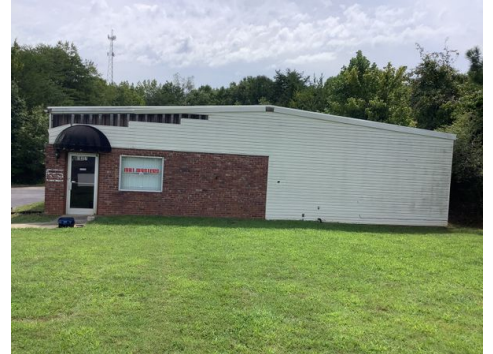
5.2.2 Walls/Cladding

CLADDING - GAPS PRESENT

There were gaps present in the cladding at the referenced area(s). This can allow for moisture, insect, and/or rodent entry into the structure. Repairs are recommended to be conducted to properly flash, seal, or fill the gaps by a qualified contractor.

Contact a qualified professional.

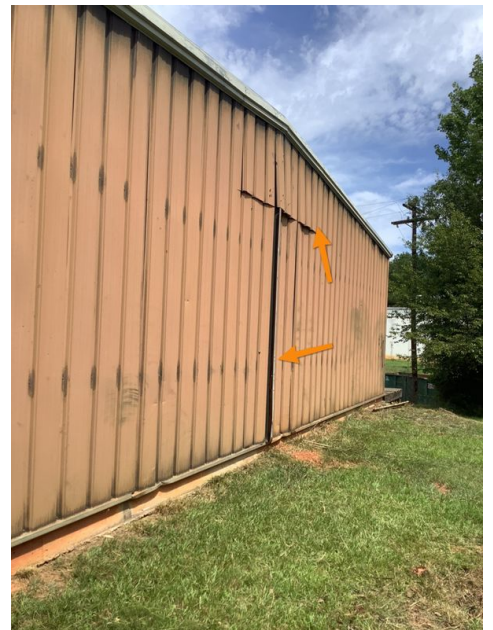
5.2.4 Walls/Cladding

ALUMINUM SIDING - DAMAGED

Sections of the aluminum siding were damaged or had holes present from past modifications. Repairs or replacement as necessary to prevent moisture infiltration is recommended by a qualified person.

Contact a qualified siding specialist.

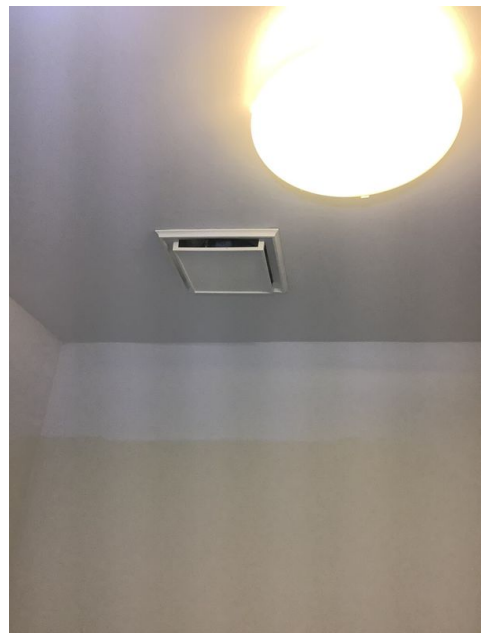
6.4.1 Ventilation

VENTILATION FAN - NOT FUNCTIONAL

The referenced bath ventilation fan did not operate when tested. Repairs or replacement as needed is recommended to be performed by a licensed electrician for proper operation.

Contact a qualified electrical contractor.

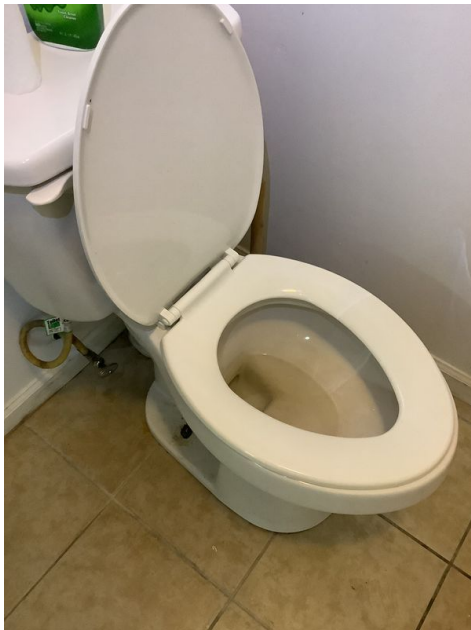
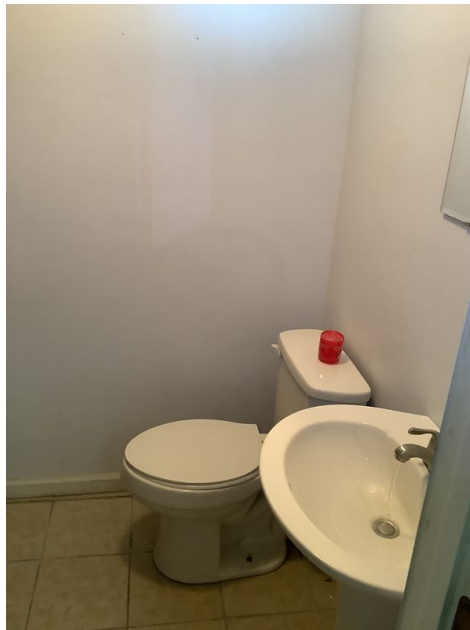
6.11.1 Toilet(s)

TOILET - LOOSE AT FLOOR

The toilet was loose at the floor anchor bolts. This can hinder a proper connection between the wax ring and toilet flange, which could allow for leaking. Evaluation of the toilet and wax ring, and re-securing as needed to ensure no leaking will occur is recommended to be conducted by a licensed plumber.

Contact a qualified plumbing contractor.

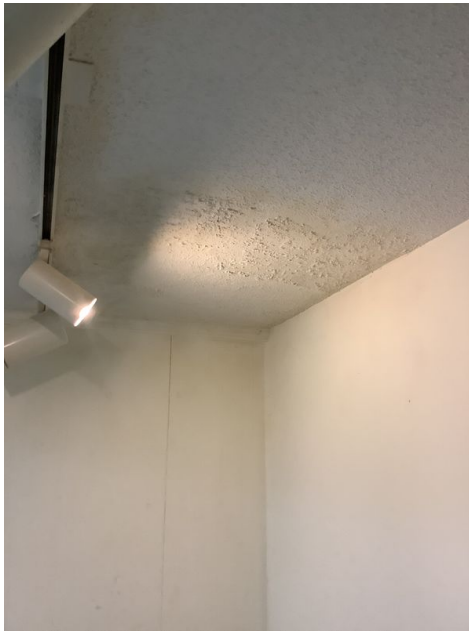
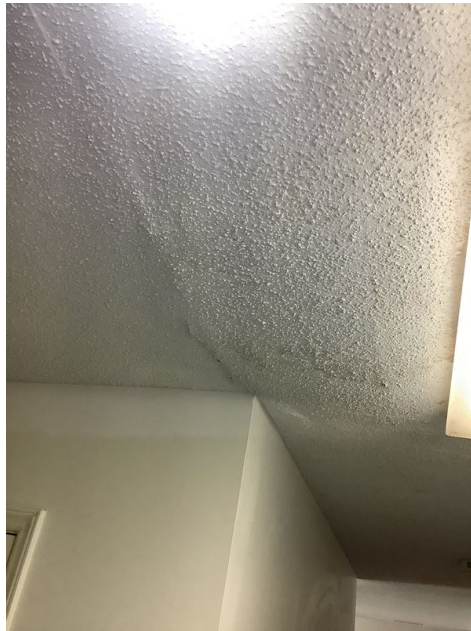
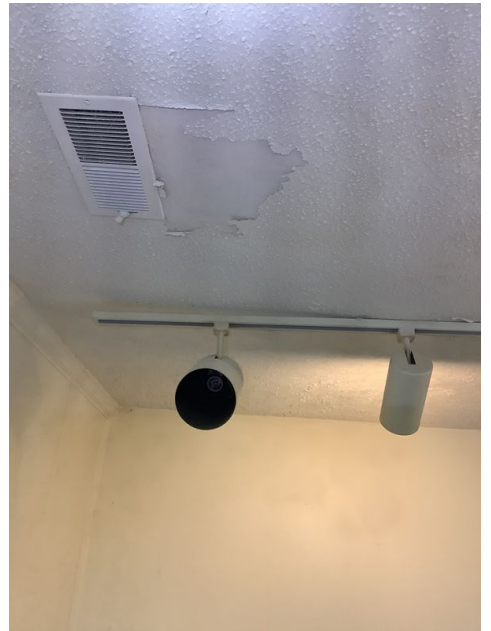
7.8.1 Ceiling Condition

CEILING(S) - PATCHING PRESENT

Patched or repaired area(s) were present on the ceiling in the referenced area(s). I recommend consulting with the seller(s) as to why the patching was conducted along with obtaining any applicable invoices or records of the repairs.

Contact the seller for more info

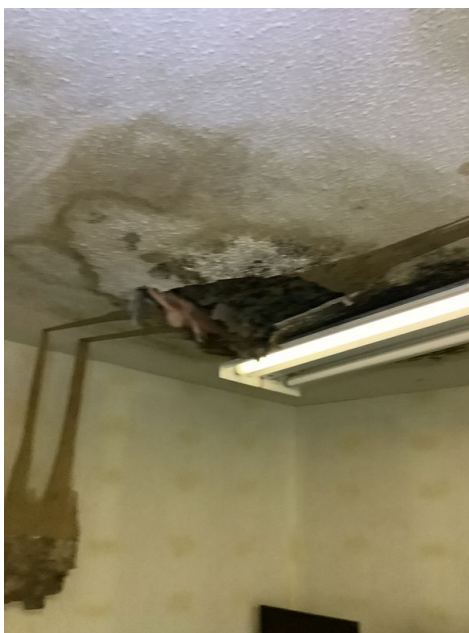
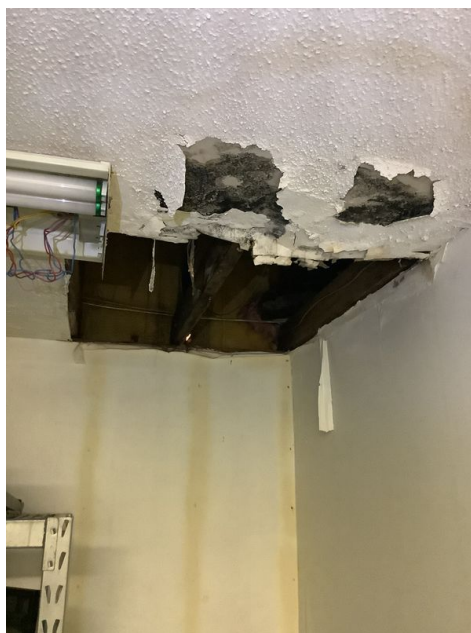
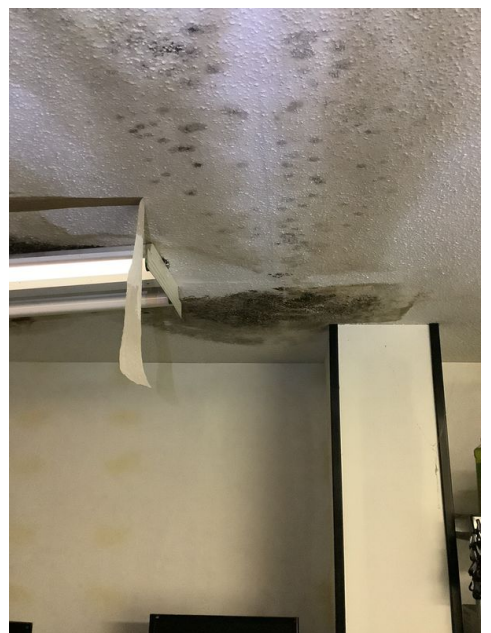
7.8.2 Ceiling Condition

DRYWALL - DAMAGE

There was drywall damage present. Repairs are recommended as needed by a drywall contractor or other qualified person.

Contact a qualified professional.

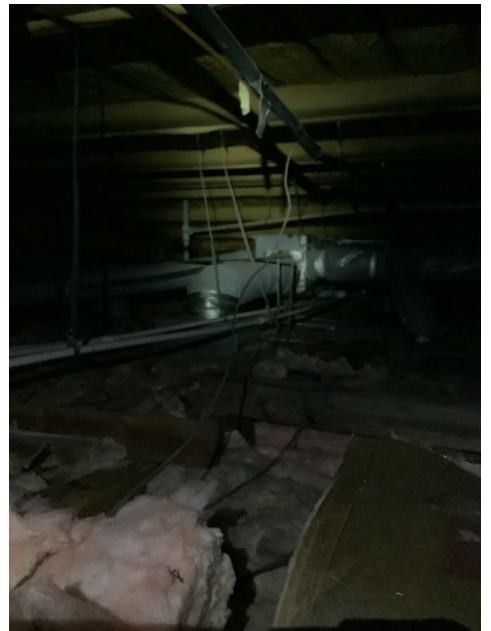
8.1.1 General Info

HVAC NOT FUNCTIONAL - COOLING MODE

The HVAC was not functional in cooling mode utilizing normal operating controls, at the time of inspection. The thermostat was set to cool and the air handling unit or condensing unit never initiated. All breakers and disconnects were on at the time of inspection. Repairs are recommended to be conducted as needed for proper operation by an HVAC contractor.

Contact a qualified heating and cooling contractor

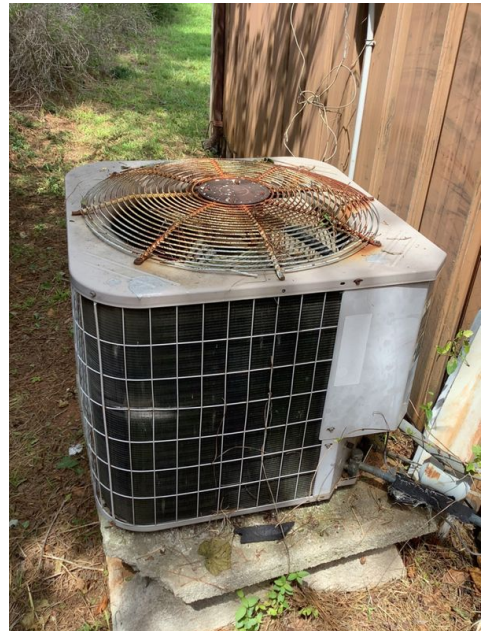
8.1.2 General Info

HVAC NOT FUNCTIONAL - HEATING MODE

The HVAC was not functional in heating mode utilizing normal operating controls, at the time of inspection. The thermostat was set to heat and the air handling unit or furnace unit never initiated. All breakers and disconnects were on at the time of inspection. Repairs are recommended to be performed as needed for proper operation by an HVAC contractor.

Contact a qualified heating and cooling contractor

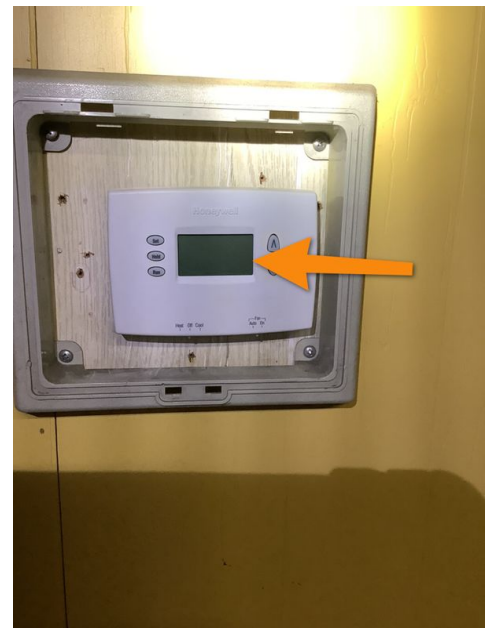
8.8.1 Thermostat(s)

THERMOSTAT - NOT FUNCTIONING PROPERLY

The thermometer on the thermostat read 80 degrees at the time of inspection, while the interior ambient temperature was closer to 72 degrees. The thermostat appeared to be defective which could allow the HVAC unit to run needlessly, increasing power bills. Replacement of the thermostat is recommended by a qualified person.

Contact a qualified professional.

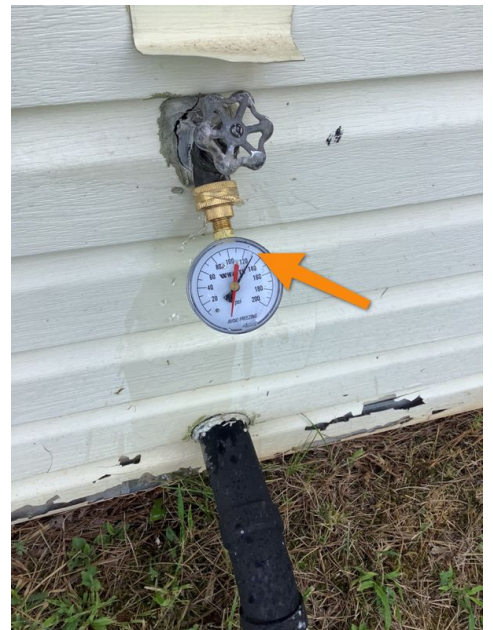
11.4.1 Water Pressure

ELEVATED WATER PRESSURE

The water pressure tested greater than 80psi at the time of inspection. 80 psi is the maximum pressure recommended to protect water distribution pipes from leaking due to pressure (60-70psi is preferred). Pressure regulators are only adjustable from 25-75psi, and any pressure readings over 75psi are typically from a defective regulator (if present). Repairs are recommended to be conducted as needed by a licensed plumber to bring the water pressure under 80psi.

Contact a qualified plumbing contractor.

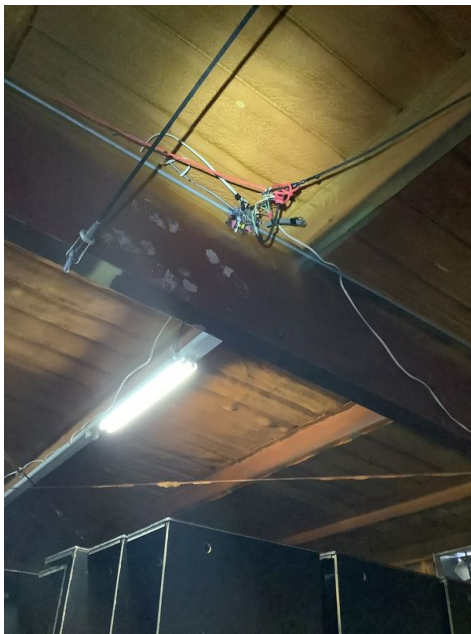
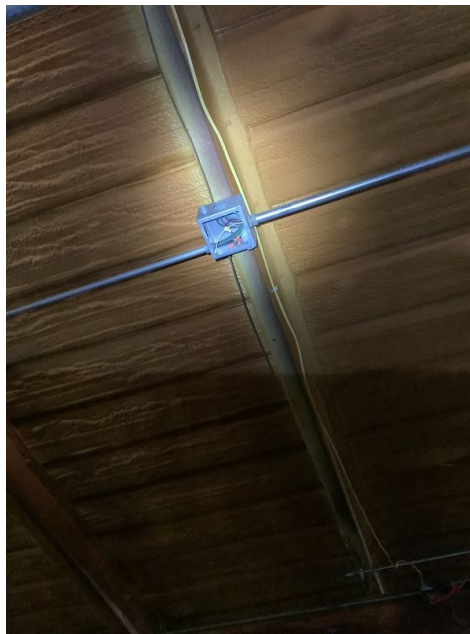
12.7.1 Branch Wiring

WIRING - SPLICES MADE OUTSIDE OF ELECTRICAL BOX

SFTY - There were wiring splices that were made outside of electrical box(es). This can be a potential fire or electrocution hazard in applicable situations. Any wiring connections/splices made outside of an electrical box in the building are recommended to be made in a proper box by a licensed electrician for safety.

Contact a qualified electrical contractor.

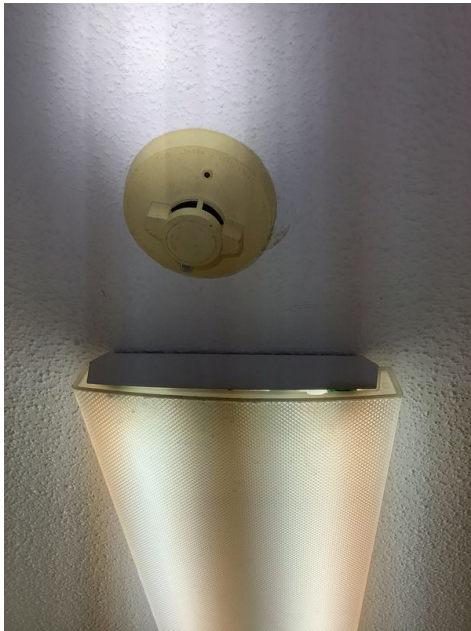
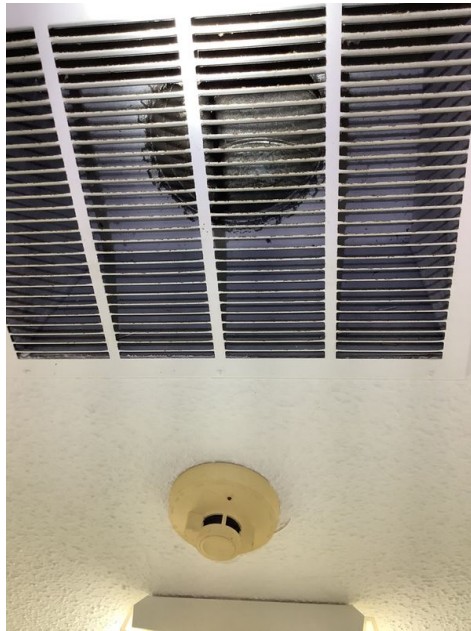
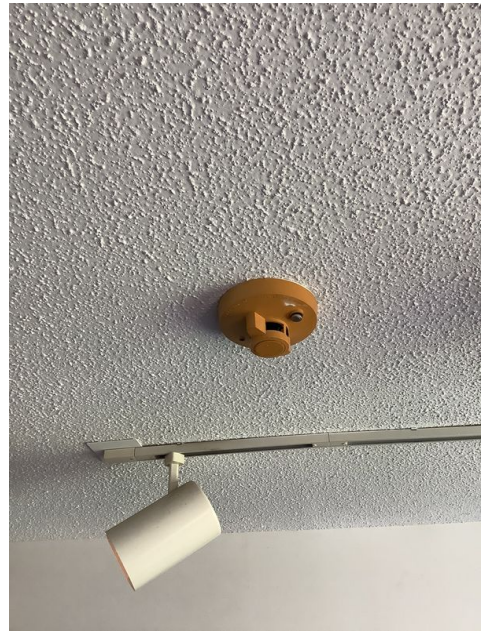
12.12.1 Smoke Alarms/Detectors

SMOKE DETECTOR(S) - DISCOLORED

There were smoke detector(s) present that were "yellowed" in color. This is typically an indicator that the detector(s) are past 10 years of age. Multiple sources recommend replacing smoke detectors every five to ten years.

Contact a qualified professional.

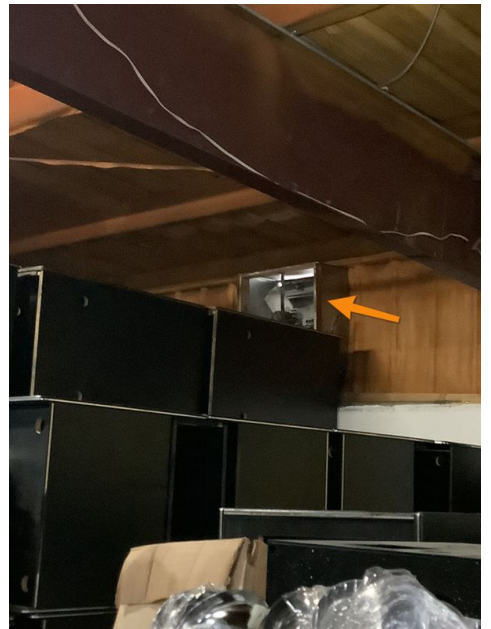
13.4.1 Ventilation

POWERED FAN - NOT FUNCTIONAL

The thermostatically controlled fan was not functional at the time of inspection. Repairs or replacement as needed is recommended by a licensed electrician.

Contact a qualified electrical contractor.

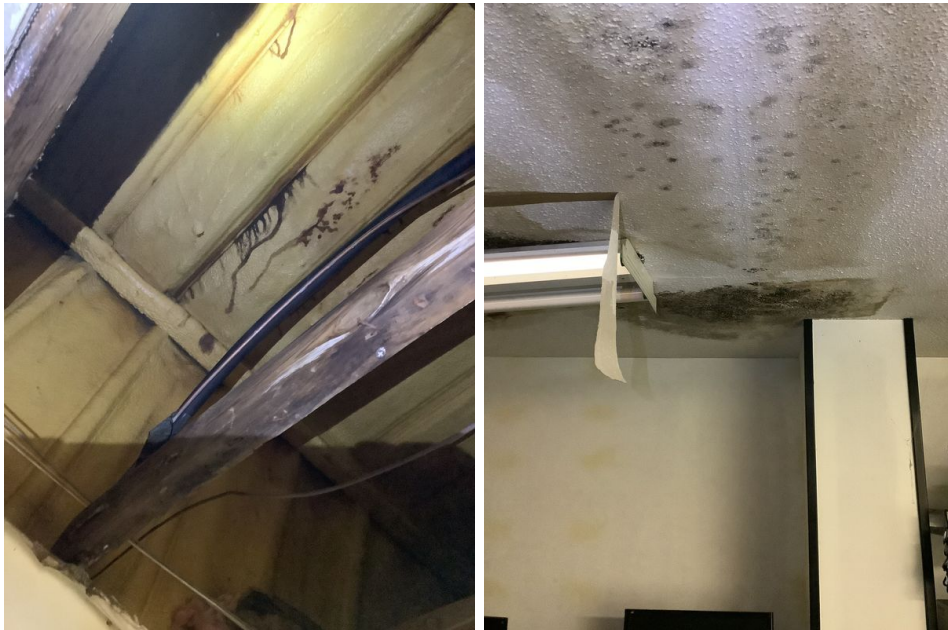
15.5.1 Roof Structure - WMC

ROOF STRUCTURE - WATER DAMAGE PRESENT

There was moisture/water damage present on areas of the roof structure and/or decking in the attic. I can only report on the conditions as they existed at the time of inspection and can not confirm if this damage is from a past or present leak. I recommend inquiring with the seller(s) concerning any repairs in association with the leak, and having a roofing contractor make repairs to any damage present as needed.

Contact a qualified roofing professional.

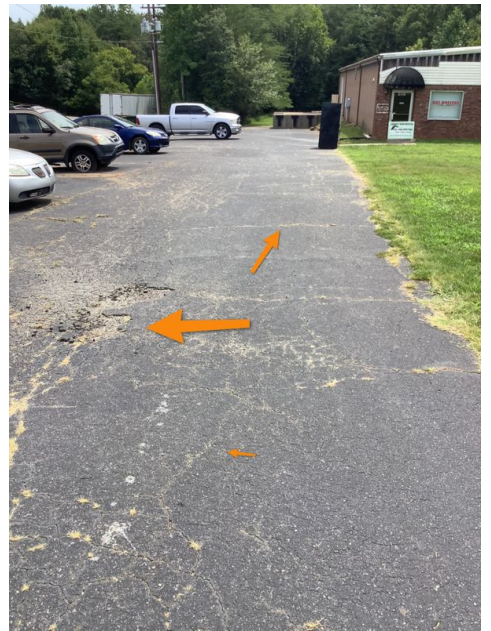
ASPHALT - CRACKING AND/OR DETERIORATION

There was some degree of cracking and/or damage present to the driveway asphalt surface. If a concern, have an asphalt paving company or other qualified person to evaluate for repair.

Contact a qualified driveway contractor.

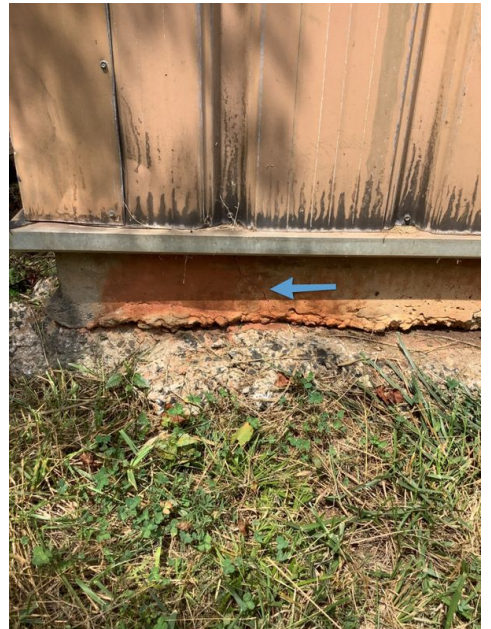
CRACKING - MINOR

Minor cracking was present on the referenced concrete slab (<1/8 inch wide). These can be from some degree of settlement or movement, from admixtures or the composition of the concrete, or even the weather conditions when the concrete was poured. It is recommended to seal these cracks at a minimum to prevent water seepage from hydrostatic pressure.

Contact a qualified professional.

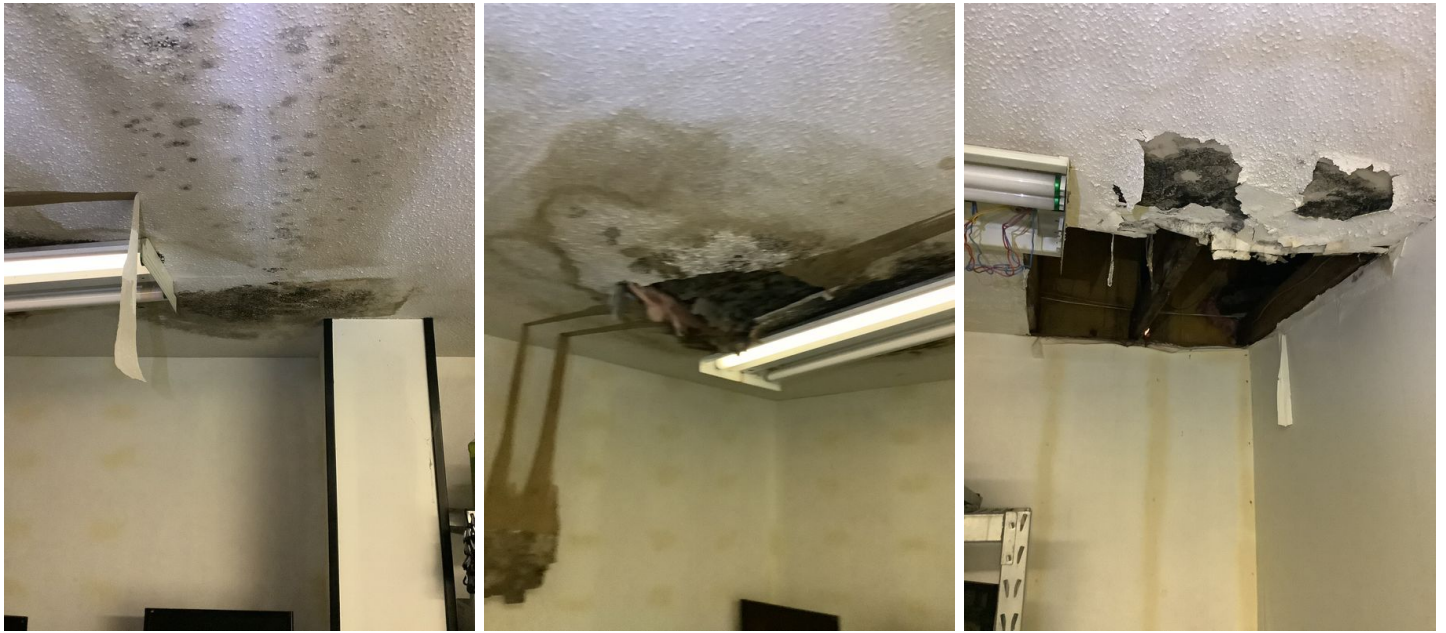
FUNGAL GROWTH PRESENT ON SURFACE(S)

There was fungal growth present on the referenced surface(s) or present in the referenced area(s).

1. Evaluation and repairs to the source of the moisture allowing the formation of the growth are recommended to be conducted by a qualified contractor.
2. Collecting samples of the growth and sending the samples to an accredited laboratory is recommended to be conducted by a mold inspector.
3. If the testing results of the fungal growth are determined to be mold, evaluation and remediation is recommended to be conducted by an environmental contractor.
